# Sustainable Implementation of Universal Design in Slums: A Case Study of Taman Odah Bekesah, Samarinda

Dzulfajrie Rahim<sup>1\*</sup>, Asep Yudi Permana<sup>2</sup>, Diah Cahyani Permana Sari<sup>3</sup>

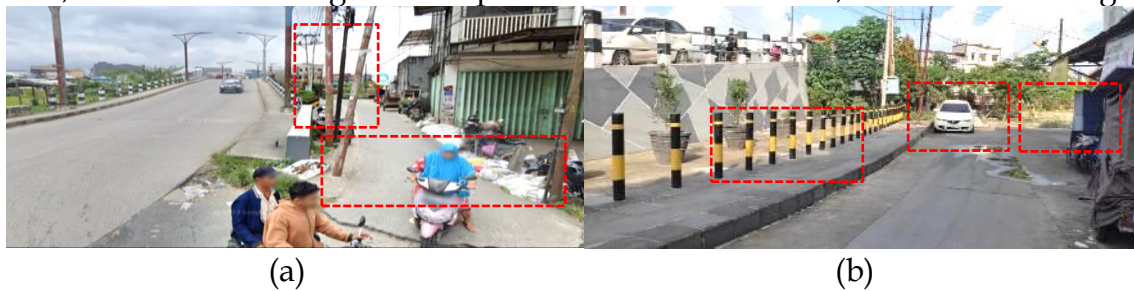
**Figure 2.** Western Entrance. (a) Objects Around Entrance, (b) Vehicle Circulation and Hard Material Elements

Based on figure 2, problems found in photo (a): the entrance width is only available 2.1 m with a turning radius at the entrance area attached to the abutment side of the pedestrian bridge so that 4-wheeled users must take turns in order to enter the park area. Utility poles block the provision of pedestrian access. In photo (b) after passing through the narrowed entrance there is a 1.2 m wide pedestrian path, but there is no guiding path available as a direction for disabilities. The bollards placed are good enough, aiming to prevent the area from becoming a parking lot, but result in the placement of vehicles on the side of the road that disturb road users. At the end of the road towards the park, the corner is broken without any radius minimum for 4-wheeled vehicle maneuvering.

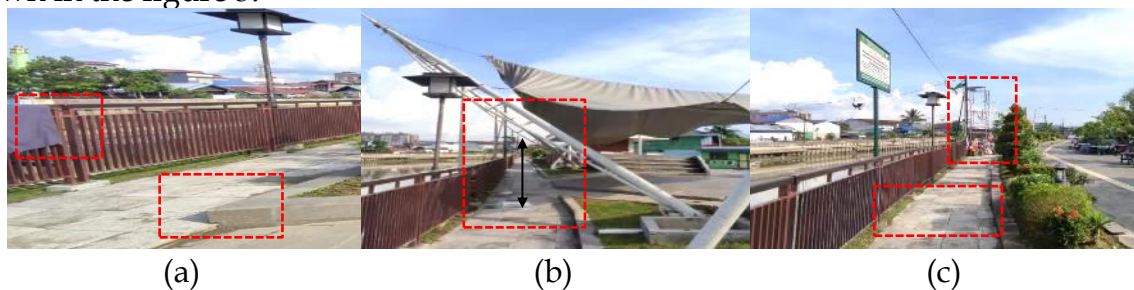
**Figure 3.** Pedestrian Paths. (a) Planter box and Hand Rails, (b) Structure of Membrane Roof, (c) Hard Material Elements

Based on figure 3, problems found in photo (a): The hand rail is used as a drying area by the surrounding community and there is a planter box with sharp corners. In photo (b): iron/pole supporting the membrane roof in the sloping amphitheater area, the height is

not significant ( $\pm 1.75 - 1.80$  cm right on the pedestrian path). In photo (c): there are no guideways, no directional signs and evacuation routes and construction/repair work that is not equipped with APK (Occupational Protective Equipment) was found as standard in construction OSH (Occupational Safety and Health).

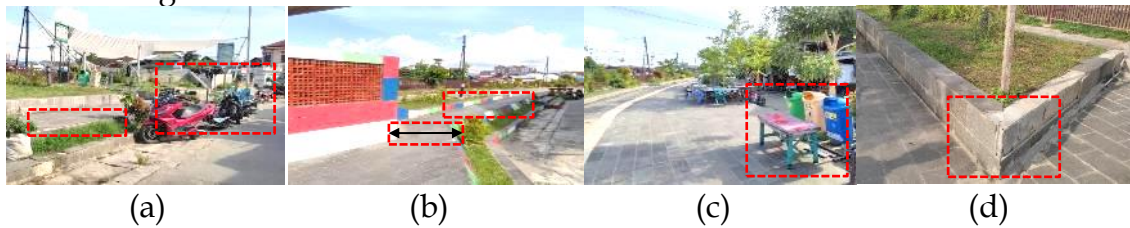
**Figure 4.** Pedestrian Paths. (a) Planter box and Hand Rails, (b) Structure of Membrane Roof, (c) Hard Material Elements

Based on figure 4, problems found in photo (a): the difference in height/level between the park pavement area and the planter area without being limited by curbs/canstones. In addition, because the park is close to a slum neighborhood, people do not orderly place vehicles, carts, and clothes drying places. In photo (b): the difference in height/level between the park pavement area and the planter area without curbs/canstones. There is also an access clearance of less than 90 cm, making it impassable for wheelchair users. In photo (c): inappropriate placement of community belongings in place, blocking neighborhood trash cans. In photo (d): there are planter shapes boxes with sharp corners.

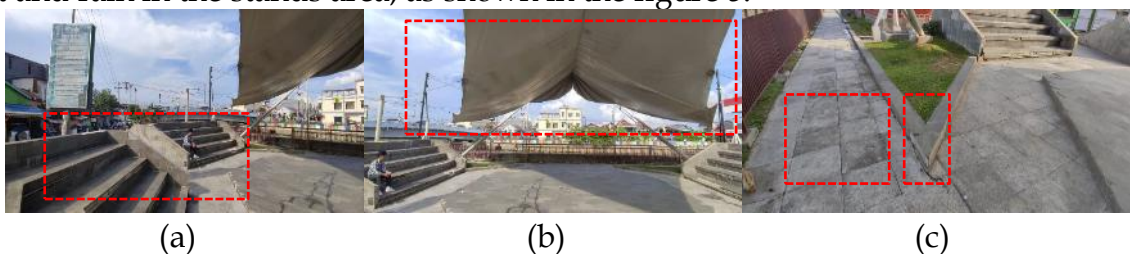
**Figure 5.** Amphitheater. (a) Grandstand Area, (b) Membrane Roof, (c) Planter and Hard Material Elements

Based on figure 5, problems found in photo (a): in the grandstand area, there is no hand railing according to the standard. The height of the grandstand area is 280 cm from the ground floor, so there needs to be a safety fence. In photo (b): the membrane roof does

not completely cover the grandstand area, so it is less than optimal to provide shade for users of the grandstand area. In photo (c): there is no guideway, no directional signs and evacuation routes. In addition, there are planter boxes that have sharp corners and are not friendly to children/disabled users.

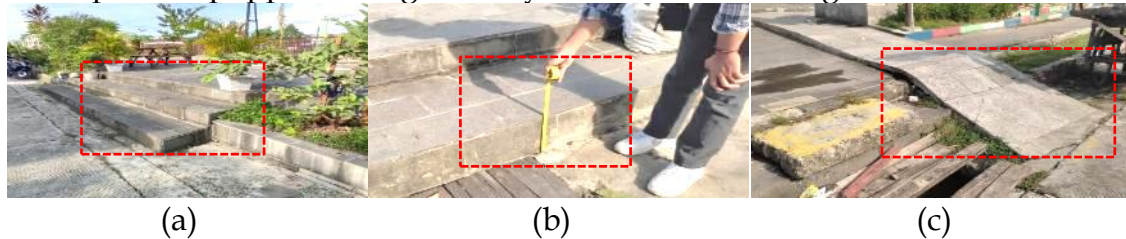
Figure 6. Stairs and Ramps. (a-b) Park Steps, (c) Park Ramps

Based on figure 6, problems found in photos (a) and (b): the height (optride) of the steps is more than 18 cm which is the recommended size. The width (antride) of the steps varies between 25-30 cm, without step nosing. In photo (c): ramp with terasso tile pavement 130 cm wide, not equipped with a guide path, slope  $>5^\circ$  and no safety curb. There is an uncovered drainage hole beside the ramp.

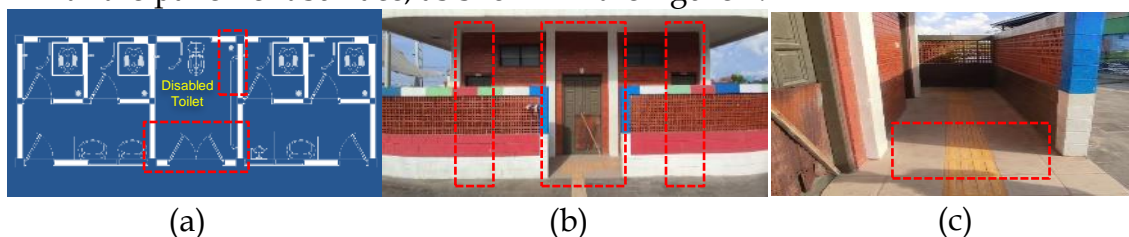
The rest room available are separate toilets for men and women and special toilets for the disabled. The total area of the toilet area along with the hallway/circulation is 60 m<sup>2</sup>. The toilet area for men and women is 2 rooms each with a size of 1.5x1.325 m and free space (sink) 1 room each with a size of 1.5x1.325 m. The area of the disabled toilet is 2x2.65 m. Problems found in photo (a): The door opening of the disabled toilet leads into the room, the distance between the hand rail inside the toilet and the toilet is  $>60$  cm. In photo (b): Based on observation, the toilets are not used and locked because the management is not running well, so the existence of these toilets is not effective. The utility/direction signs and toilet type symbols are less visible/less large, and the door handle on the disabled toilet is not as recommended with a horizontal shape extending the width of the door leaf. In photo (c): the guideway in the hallway is not continuous to the front of the toilet door, and there are obstacles in the outer area of the toilet (vent pipe of the wastewater treatment system, manhole) that are not visible flush with the pavement surface, as shown in the figure 7.

**Figure 7.** Rest Room. (a) Layout Plan, (b) Openings of Rest Room, (c) Guideway to The Room, (d) Corridor, (e) Objects Around Pavement Surface

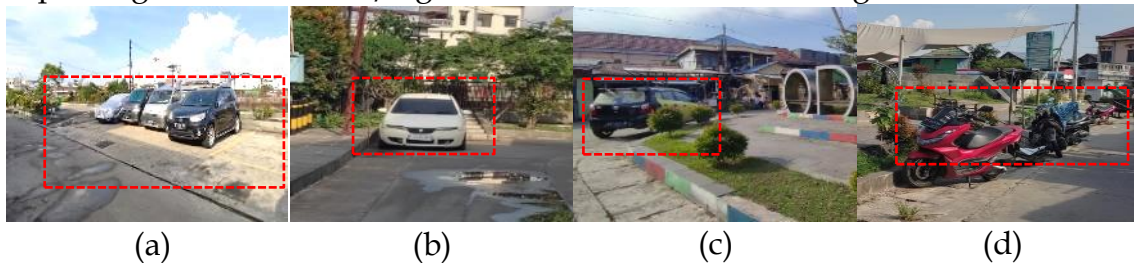
**Figure 8.** Parking Space. (a) Vehicles, (b) Vehicle Circulation, (c-d) Vehicles Around Street

Based on the figure 8, problems found in photo (a): Based on the marking lines, the placement of 2-wheeled parking is filled with 4-wheeled vehicles. For 4-wheeled parking, it is dominated by vehicle owners from the community who live around the park area, so visitors do not get access to parking. Then, there are no parking facilities for people with disabilities/disabilities. Appropriately, parking for the disabled is on the side that is close/adjacent/not far from ram access. There are no bicycle parking facilities equipped with bicycle racks. In photos (b), (c), and (d): vehicles of people living around the park area are parked, taking up the road body which is only 3-4 m wide. So that vehicle circulation is disrupted and not optimized.

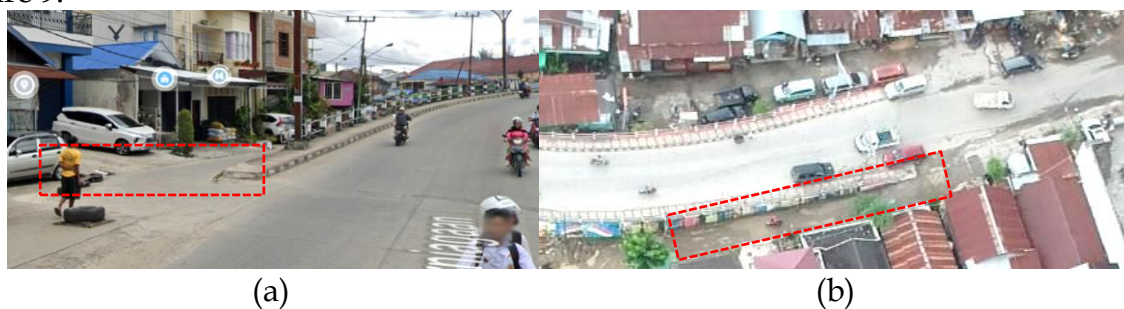
**Figure 9.** Eastern Entrance. (a) Entrance As Seen From The Front, (b) Entrance As Seen From Above

Based on the figure 9, problems found in photo (a): the entrance/entrance street width is only available 2.6 m with a turning radius at the entrance area attached to the abutment side of the pedestrian bridge so that 4-wheeled users must take turns in order to enter the park area. In photo (b) after passing the entrance there is no pedestrian access/pedestrian

area. At the end of the road towards the park, the bend angle is broken without any minimum radius for maneuvering 4-wheeled vehicles.

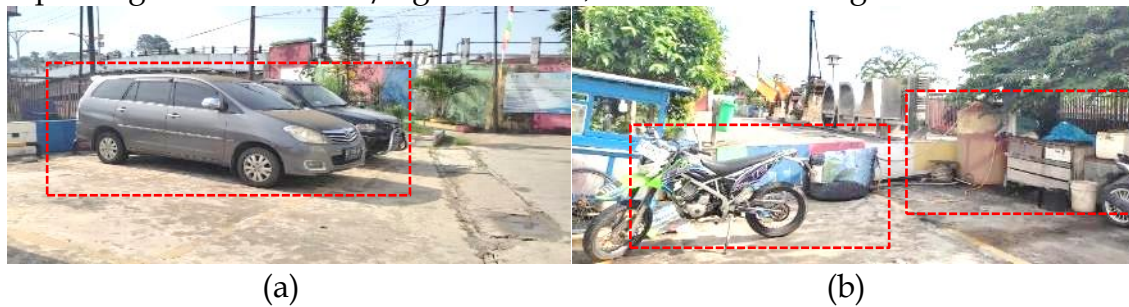
**Figure 10.** Parking Space. (a) Vehicles Parked in the Parking Space, (b) Objects Around Parking Space

Based on the figure 10, problems found in photo (a): parking for 4-wheeled and 2-wheeled vehicles is dominated by vehicle owners from the community who live around the park area, so visitors do not get access to parking. Then, there are no parking facilities for people with disabilities. Appropriately, parking for the disabled is on the side that is close/adjacent /not far from ramp access. There are no bicycle parking facilities equipped with bicycle racks. In photo (b): clearly visible household items (wooden racks, water tanks, used tires, etc.) and selling places (carts) owned by people who live around the park area, taking up the parking area. So that the circulation in the parking area disrupted, and not disabled-friendly.

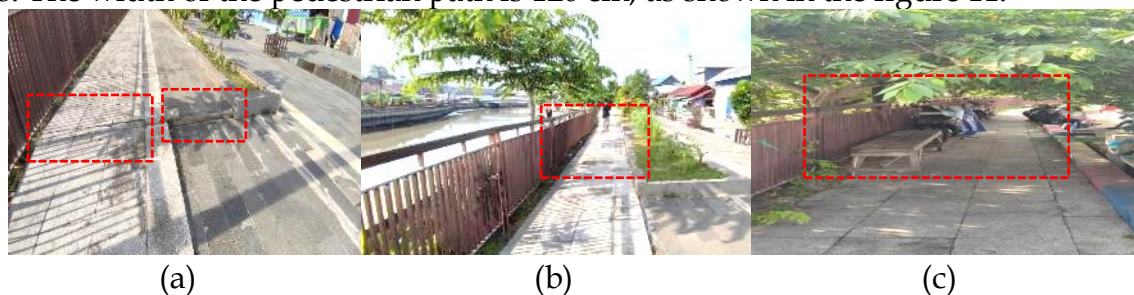
**Figure 11.** Pedestrian Paths. (a) Hard Material Surfaces, (b) Pedestrian Ways, (c) Trees Above Pedestrian Ways

Based on the figure 11, problems found in photo (a): the unavailability of guiding paths, there are no directional signs and evacuation routes, and there are obstacles in the form of level difference steps. In photo (b): there is a decrease in ground level on the pedestrian path, so there is a slope that makes it uncomfortable for pedestrian users. In photo (c): there are objects/items (traders' equipment) placed by the community around the park area that block the accessibility of the pedestrian path. Similarly, there are plants (trees) whose branches are less than 2 m high, so that it also interferes with the pedestrian path.

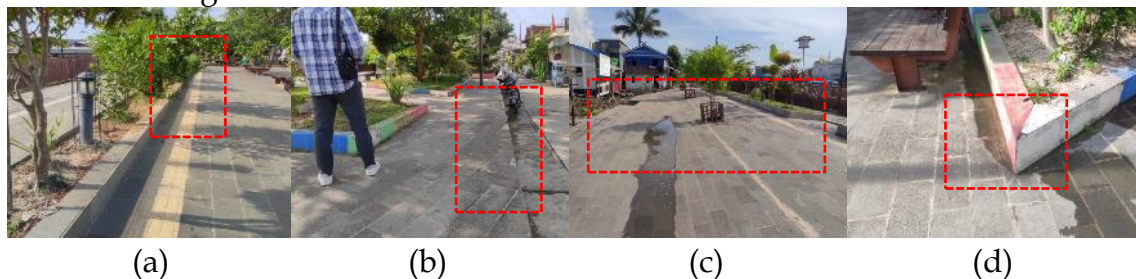
**Figure 12.** Plaza. (a) Vegetation Beside The Guide Path, (b-c) Hard Material Elements, (d) Planter

Based on the figure 12, problems found in photo (a): the disabled guide path is too close to the planter box so that users can be blocked by shady vegetation objects. In photo (b): the difference in height/level between the park pavement area and the planter area without being limited by curbs/canstones. In photo (c): land subsidence occurs on the pedestrian path, so there is a slope that makes road users uncomfortable. In photo (d): there is a planter box shape with sharp corners.

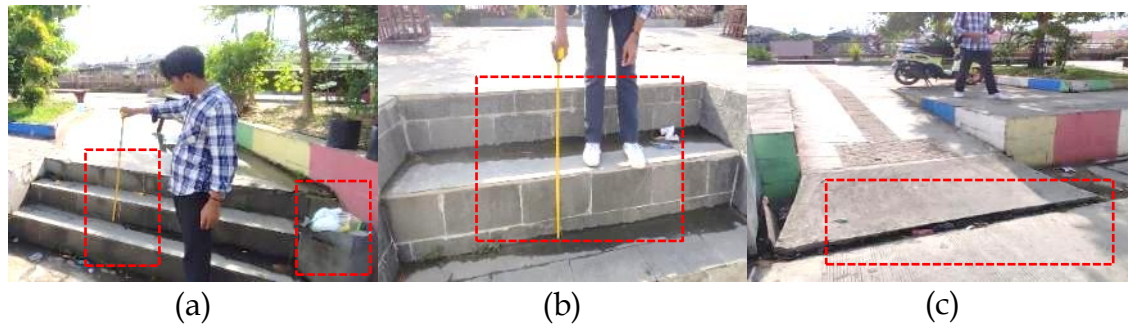
**Figure 13.** Stairs and Ramps. (a-b) Park Steps, (c) Park Ramps

In this eastern segment, there are 5 access stairs with the number of steps varying from 2 to 3 steps. Then there are 1 access ramps for wheelchair users. The stairs and ramp elements use andesite pavement or terasso tiles that are not slippery in texture, and some of the ramps are equipped with guideways. Problems found in photos (a) and (b): the height (optride) of the steps is more than 18 cm which is the recommended size. The width (antride) of the steps varies between 25-30 cm, without step nosing. In photo (c): 130 cm wide ramp with guideway and warning tiles, slope of about  $<5^\circ$ , not equipped with hand railing, at the end of the ram there is no curb and there are obstacles which makes wheelchair movement difficult, as shown in the figure 13.

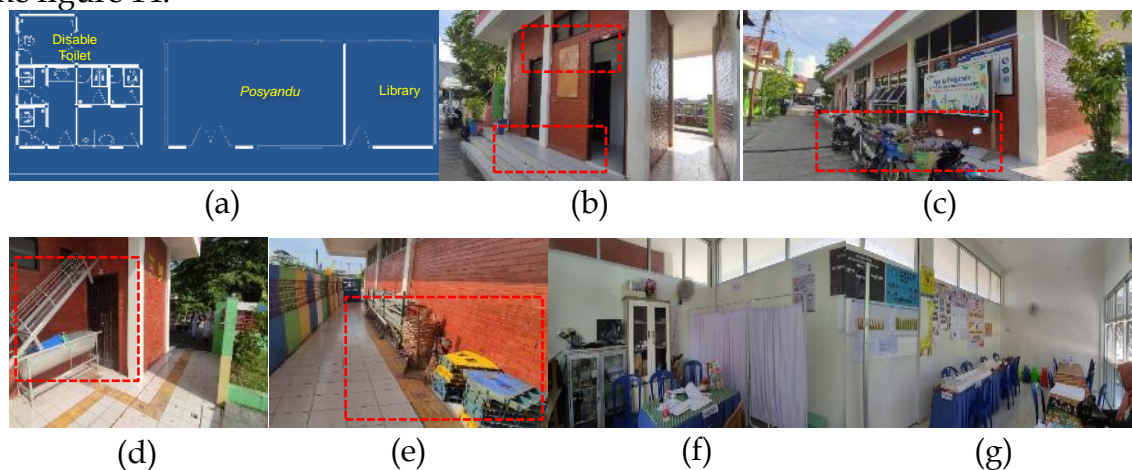
**Figure 14.** Integrated Buildings. (a) Layout Plan, (b) Openings of Rest Room, (c) Vehicles parked in front of the Rest Room, (d-e) Corridor, (f-g) Posyandu Room

Based on the layout plan, the toilet area for men and women is 2 rooms each with a size of 1.5x1.5 m and free space (sink) each 1 room measuring 1.5x3 m. The area of the special toilet for the disabled is 2x2.65 m. Problems found in photo (a): the placement of the disabled toilet is far from the access to the posyandu, and requires a winding maneuver through a 1.2-1.5 m wide hallway. In photo (b): based on observations, the toilet is not used regularly and is locked due to security factors. Utility signs and toilet type symbols are less visible/less large, and the distance between the door and the stairs is only 60 cm. The door handle on the disabled toilet is not as recommended with a horizontal shape extending the width of the door leaf. In photo (c): 2-wheeled vehicles are parked not in their proper places. In photo (d): the disabled toilet is locked and not functioning, there are items blocking the path to the toilet. In photo (e): guided path in the hallway of the back area, there are obstacles in the form of improperly placed items. In photos (f) and (g): inside the posyandu room based on the layout, it follows the general standards of the integrated buildings. There is also an action room that functions as a lactation room.
