Sustainable Implementation of Universal Design in Slums: A Case Study of Taman Odah Bekesah, Samarinda

Dzulfajrie Rahim^{1*}, Asep Yudi Permana¹, Diah Cahyani Permana Sari¹

^{1*}Universitas Pendidikan Indonesia, Bandung, Indonesia

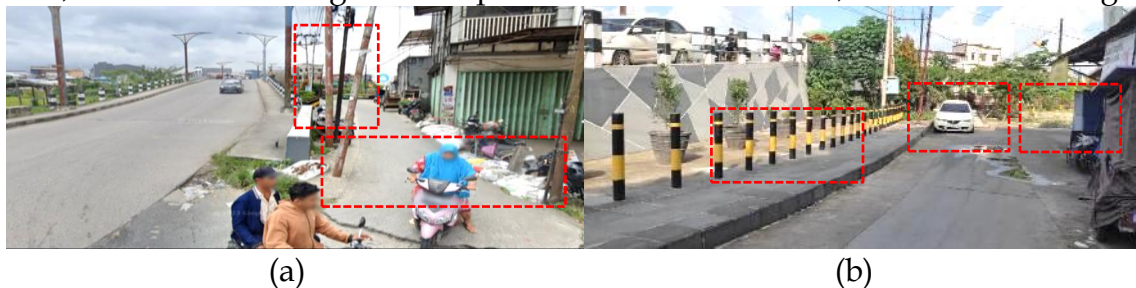
Figure 2. Western Entrance. (a) Objects Around Entrance, (b) Vehicle Circulation and Hard Material Elements

Based on figure 2, problems found in photo (a): the entrance width is only available 2.1 m with a turning radius at the entrance area attached to the abutment side of the pedestrian bridge so that 4-wheeled users must take turns in order to enter the park area. Utility poles block the provision of pedestrian access. In photo (b) after passing through the narrowed entrance there is a 1.2 m wide pedestrian path, but there is no guiding path available as a direction for disabilities. The bollards placed are good enough, aiming to prevent the area from becoming a parking lot, but result in the placement of vehicles on the side of the road that disturb road users. At the end of the road towards the park, the corner is broken without any radius minimum for 4-wheeled vehicle maneuvering.

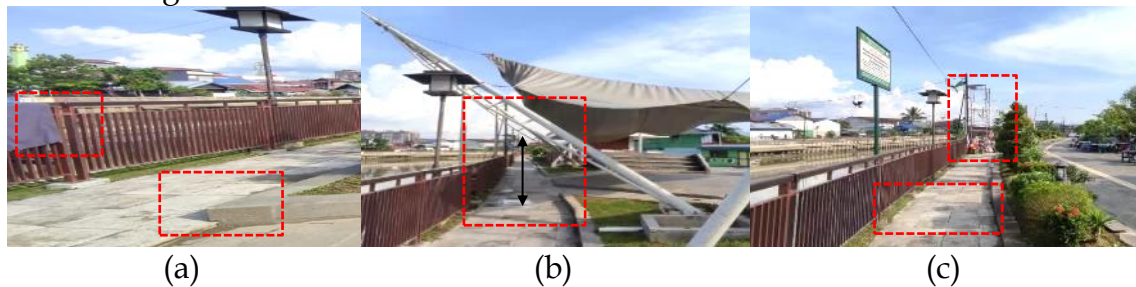
Figure 3. Pedestrian Paths. (a) Planter box and Hand Rails, (b) Structure of Membrane Roof, (c) Hard Material Elements

Based on figure 3, problems found in photo (a): The hand rail is used as a drying area by the surrounding community and there is a planter box with sharp corners. In photo (b): iron/pole supporting the membrane roof in the sloping amphitheater area, the height is not significant ($\pm 1.75 - 1.80$ cm right on the pedestrian path). In photo (c): there are no guideways, no directional signs and evacuation routes and construction/repair work that is not equipped with APK (Occupational Protective Equipment) was found as standard in construction OSH (Occupational Safety and Health).

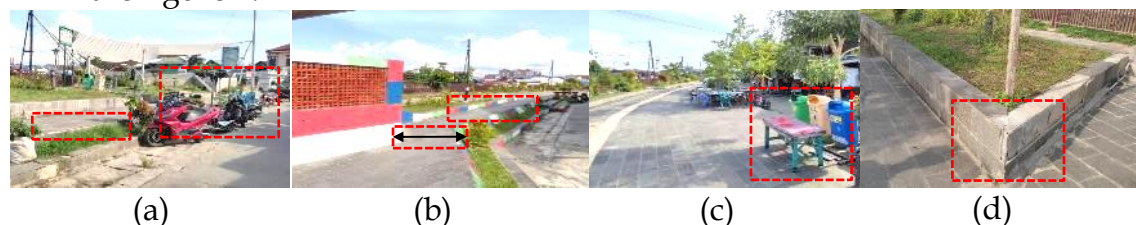
Figure 4. Pedestrian Paths. (a) Planter box and Hand Rails, (b) Structure of Membrane Roof, (c) Hard Material Elements

Based on figure 4, problems found in photo (a): the difference in height/level between the park pavement area and the planter area without being limited by curbs/canstones. In addition, because the park is close to a slum neighborhood, people do not orderly place

vehicles, carts, and clothes drying places. In photo (b): the difference in height/level between the park pavement area and the planter area without curbs/canstones. There is also an access clearance of less than 90 cm, making it impassable for wheelchair users. In photo (c): inappropriate placement of community belongings in place, blocking neighborhood trash cans. In photo (d): there are planter shapes boxes with sharp corners.

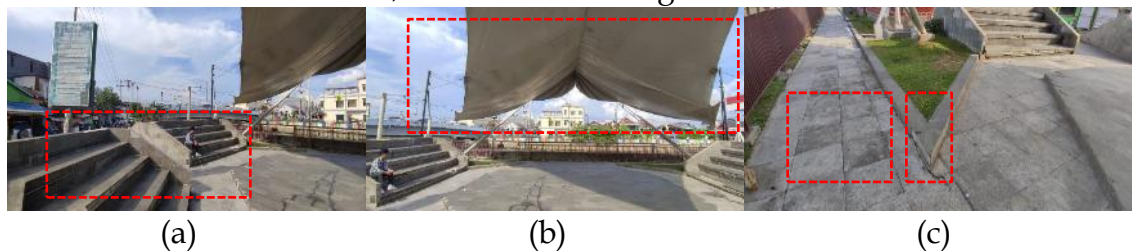
Figure 5. Amphitheater. (a) Grandstand Area, (b) Membrane Roof, (c) Planter and Hard Material Elements

Based on figure 5, problems found in photo (a): in the grandstand area, there is no hand railing according to the standard. The height of the grandstand area is 280 cm from the ground floor, so there needs to be a safety fence. In photo (b): the membrane roof does not completely cover the grandstand area, so it is less than optimal to provide shade for users of the grandstand area. In photo (c): there is no guideway, no directional signs and evacuation routes. In addition, there are planter boxes that have sharp corners and are not friendly to children/disabled users.

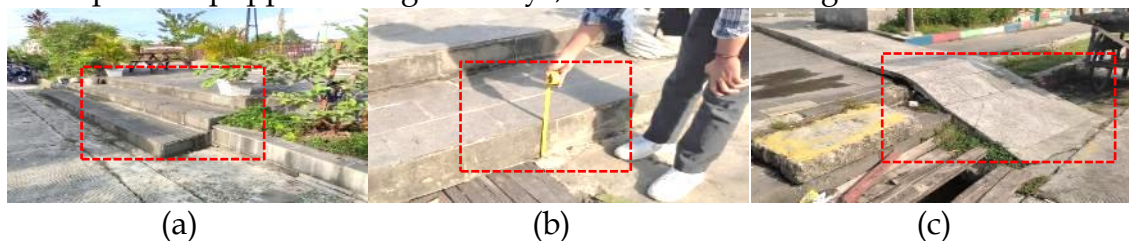
Figure 6. Stairs and Ramps. (a-b) Park Steps, (c) Park Ramps

Based on figure 6, problems found in photos (a) and (b): the height (optride) of the steps is more than 18 cm which is the recommended size. The width (antride) of the steps varies

between 25-30 cm, without step nosing. In photo (c): ramp with terasso tile pavement 130 cm wide, not equipped with a guide path, slope $>5^\circ$ and no safety curb. There is an uncovered drainage hole beside the ramp.

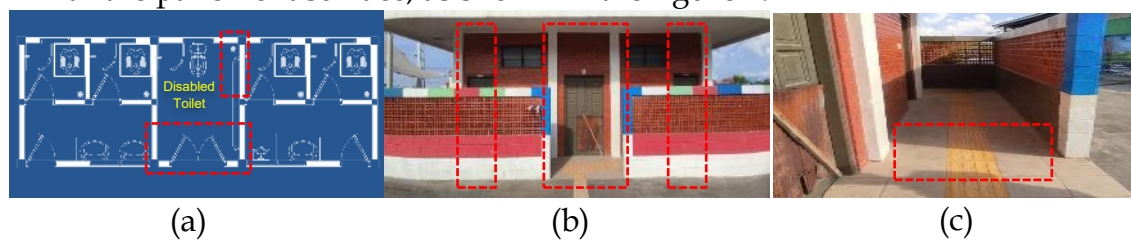
The rest room available are separate toilets for men and women and special toilets for the disabled. The total area of the toilet area along with the hallway/circulation is 60 m². The toilet area for men and women is 2 rooms each with a size of 1.5x1.325 m and free space (sink) 1 room each with a size of 1.5x1.325 m. The area of the disabled toilet is 2x2.65 m. Problems found in photo (a): The door opening of the disabled toilet leads into the room, the distance between the hand rail inside the toilet and the toilet is >60 cm. In photo (b): Based on observation, the toilets are not used and locked because the management is not running well, so the existence of these toilets is not effective. The utility/direction signs and toilet type symbols are less visible/less large, and the door handle on the disabled toilet is not as recommended with a horizontal shape extending the width of the door leaf. In photo (c): the guideway in the hallway is not continuous to the front of the toilet door, and there are obstacles in the outer area of the toilet (vent pipe of the wastewater treatment system, manhole) that are not visible flush with the pavement surface, as shown in the figure 7.

Figure 7. Rest Room. (a) Layout Plan, (b) Openings of Rest Room, (c) Guideway to The Room, (d) Corridor, (e) Objects Around Pavement Surface

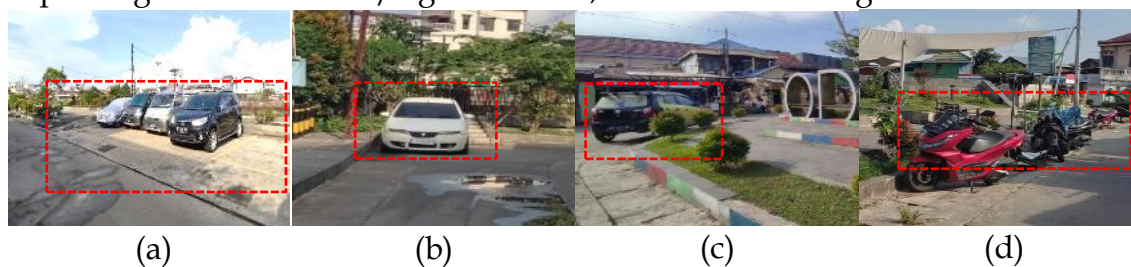
Figure 8. Parking Space. (a) Vehicles, (b) Vehicle Circulation, (c-d) Vehicles Around Street

Based on the figure 8, problems found in photo (a): Based on the marking lines, the placement of 2-wheeled parking is filled with 4-wheeled vehicles. For 4-wheeled parking,

it is dominated by vehicle owners from the community who live around the park area, so visitors do not get access to parking. Then, there are no parking facilities for people with disabilities/disabilities. Appropriately, parking for the disabled is on the side that is close/adjacent/not far from ram access. There are no bicycle parking facilities equipped with bicycle racks. In photos (b), (c), and (d): vehicles of people living around the park area are parked, taking up the road body which is only 3-4 m wide. So that vehicle circulation is disrupted and not optimized.

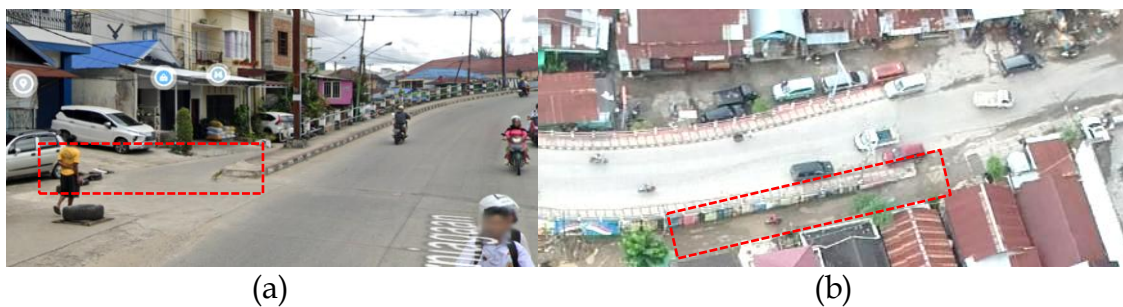
Figure 9. Eastern Entrance. (a) Entrance As Seen From The Front, (b) Entrance As Seen From Above

Based on the figure 9, problems found in photo (a): the entrance/entrance street width is only available 2.6 m with a turning radius at the entrance area attached to the abutment side of the pedestrian bridge so that 4-wheeled users must take turns in order to enter the park area. In photo (b) after passing the entrance there is no pedestrian access/pedestrian area. At the end of the road towards the park, the bend angle is broken without any minimum radius for maneuvering 4-wheeled vehicles.

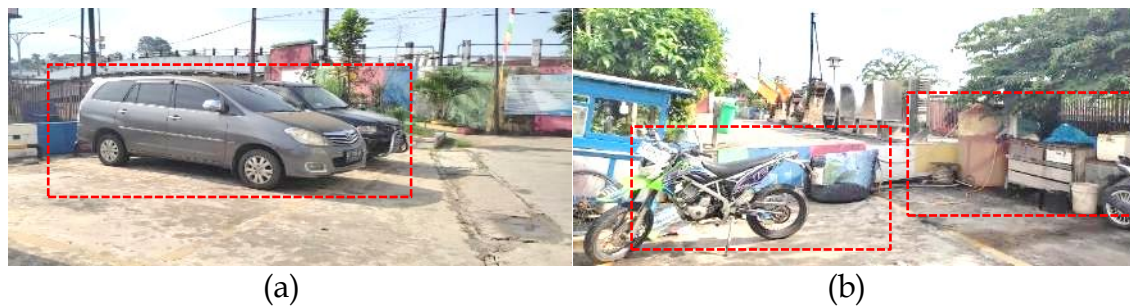
Figure 10. Parking Space. (a) Vehicles Parked in the Parking Space, (b) Objects Around Parking Space

Based on the figure 10, problems found in photo (a): parking for 4-wheeled and 2-wheeled vehicles is dominated by vehicle owners from the community who live around the park area, so visitors do not get access to parking. Then, there are no parking facilities for people with disabilities. Appropriately, parking for the disabled is on the side that is close/adjacent /not far from ramp access. There are no bicycle parking facilities equipped with bicycle racks. In photo (b): clearly visible household items (wooden racks, water tanks, used tires, etc.) and selling places (carts) owned by people who live around the park area, taking up the parking area. So that the circulation in the parking area disrupted, and not disabled-friendly.

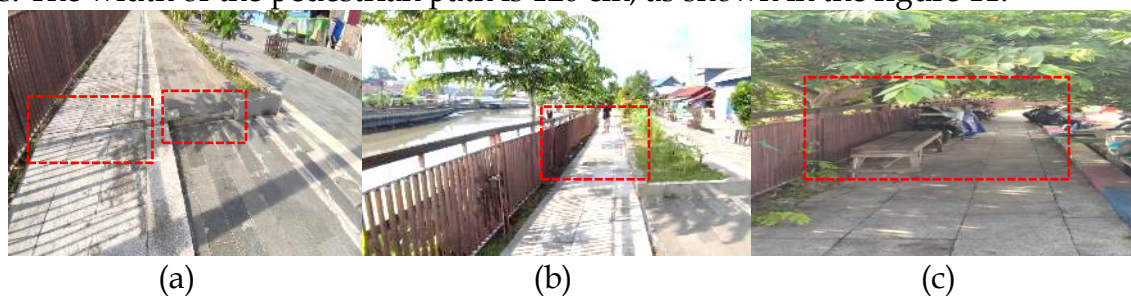
Figure 11. Pedestrian Paths. (a) Hard Material Surfaces, (b) Pedestrian Ways, (c) Trees Above Pedestrian Ways

Based on the figure 11, problems found in photo (a): the unavailability of guiding paths, there are no directional signs and evacuation routes, and there are obstacles in the form of level difference steps. In photo (b): there is a decrease in ground level on the pedestrian path, so there is a slope that makes it uncomfortable for pedestrian users. In photo (c): there are objects/items (traders' equipment) placed by the community around the park

area that block the accessibility of the pedestrian path. Similarly, there are plants (trees) whose branches are less than 2 m high, so that it also interferes with the pedestrian path.

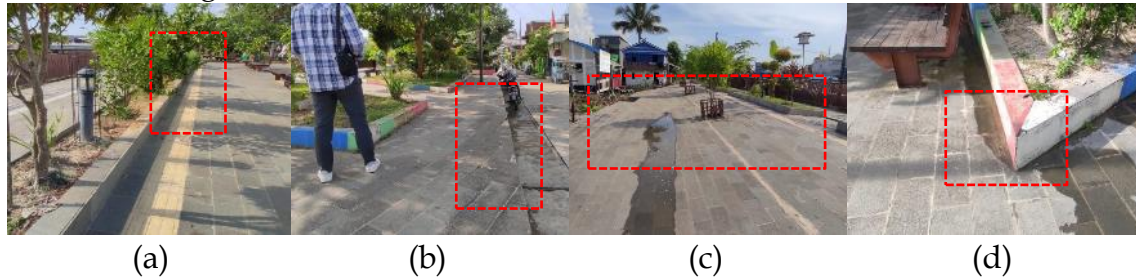
Figure 12. Plaza. (a) Vegetation Beside The Guide Path, (b-c) Hard Material Elements, (d) Planter

Based on the figure 12, problems found in photo (a): the disabled guide path is too close to the planter box so that users can be blocked by shady vegetation objects. In photo (b): the difference in height/level between the park pavement area and the planter area without being limited by curbs/canstones. In photo (c): land subsidence occurs on the pedestrian path, so there is a slope that makes road users uncomfortable. In photo (d): there is a planter box shape with sharp corners.

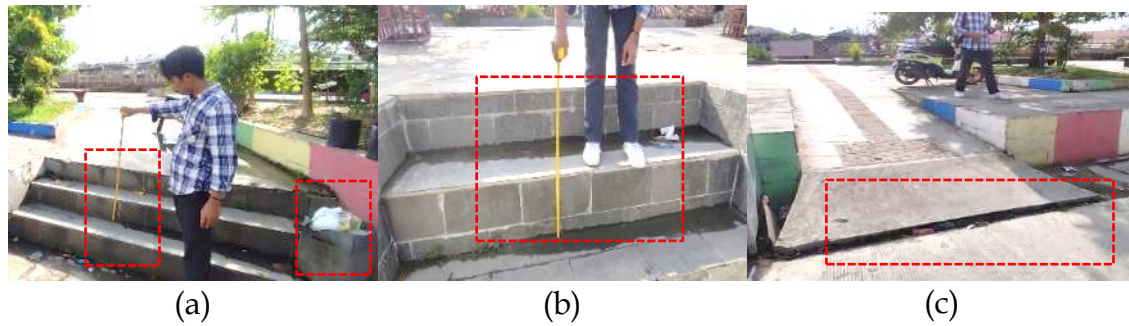
In this eastern segment, there are 5 access stairs with the number of steps varying from 2 to 3 steps. Then there are 1 access ramps for wheelchair users. The stairs and ramp elements use andesite pavement or terasso tiles that are not slippery in texture, and some of the ramps are equipped with guideways. Problems found in photos (a) and (b): the height (optride) of the steps is more than 18 cm which is the recommended size. The width (antride) of the steps varies between 25-30 cm, without step nosing. In photo (c): 130 cm wide ramp with guideway and warning tiles, slope of about $<5^\circ$, not equipped with hand railing, at the end of the ram there is no curb and there are obstacles which makes wheelchair movement difficult, as shown in the figure 13.

Figure 13. Stairs and Ramps. (a-b) Park Steps, (c) Park Ramps

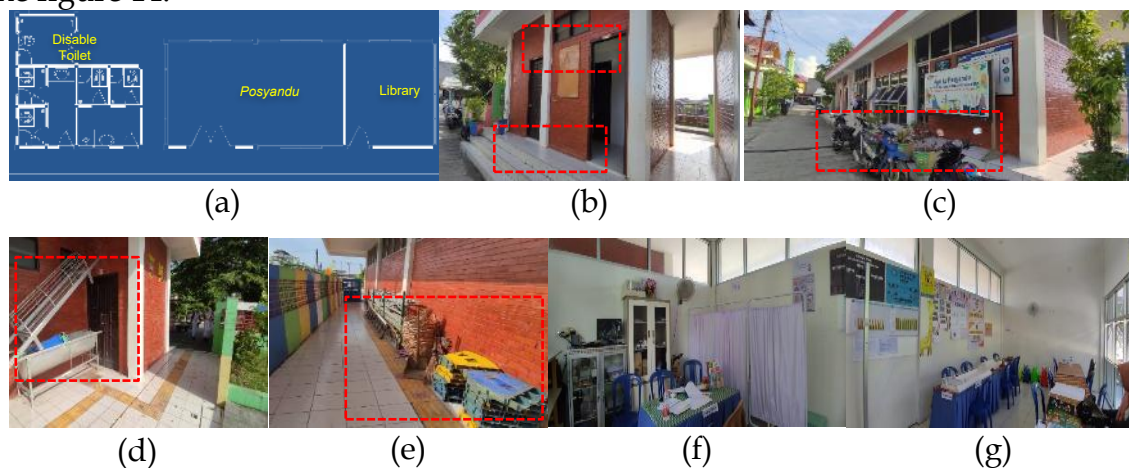
Figure 14. Integrated Buildings. (a) Layout Plan, (b) Openings of Rest Room, (c) Vehicles parked in front of the Rest Room, (d-e) Corridor, (f-g) Posyandu Room

Based on the layout plan, the toilet area for men and women is 2 rooms each with a size of 1.5x1.5 m and free space (sink) each 1 room measuring 1.5x3 m. The area of the special toilet for the disabled is 2x2.65 m. Problems found in photo (a): the placement of the disabled toilet is far from the access to the posyandu, and requires a winding maneuver through a 1.2-1.5 m wide hallway. In photo (b): based on observations, the toilet is not used regularly and is locked due to security factors. Utility signs and toilet type symbols are less visible/less large, and the distance between the door and the stairs is only 60 cm. The door handle on the disabled toilet is not as recommended with a horizontal shape extending the width of the door leaf. In photo (c): 2-wheeled vehicles are parked not in their proper places. In photo (d): the disabled toilet is locked and not functioning, there are items blocking the path to the toilet. In photo (e): guided path in the hallway of the back area, there are obstacles in the form of improperly placed items. In photos (f) and (g): inside the posyandu room based on the layout, it follows the general standards of the integrated buildings. There is also an action room that functions as a lactation room.
